On site

Alexander Hobohm of Freeland Rees Roberts Architects explains how Castle Ashby House rose from the ashes

BLAZE OF GLORY

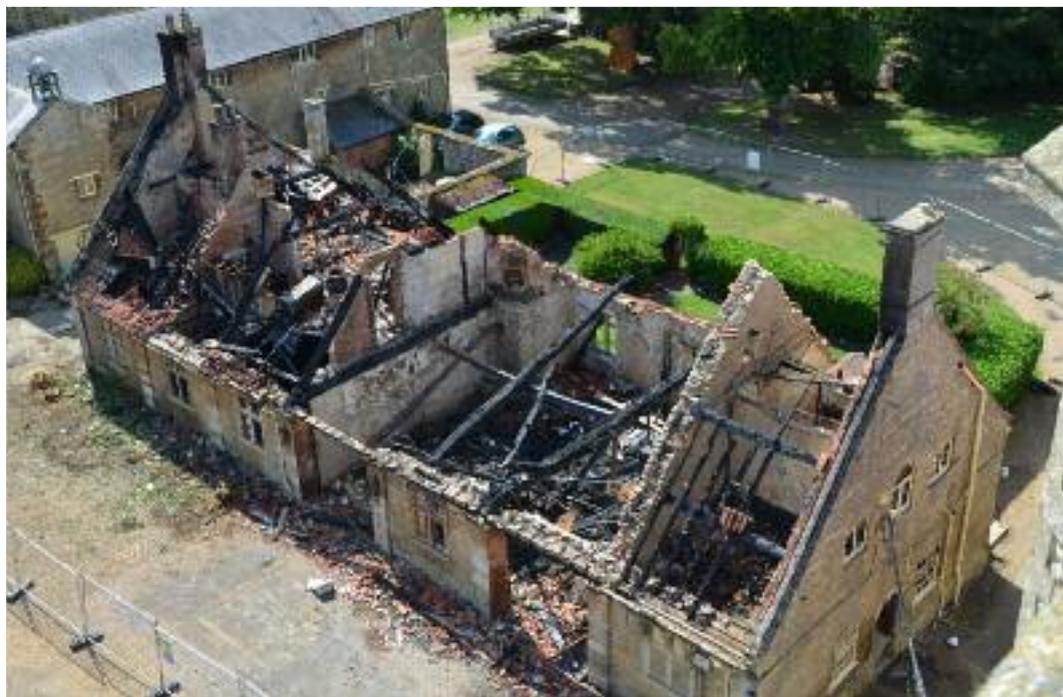
Left: Castle Ashby after the repair work had been carried out; **Inset left:** The damage done to the building by the fire; **Above:** The main staircase following the repair work

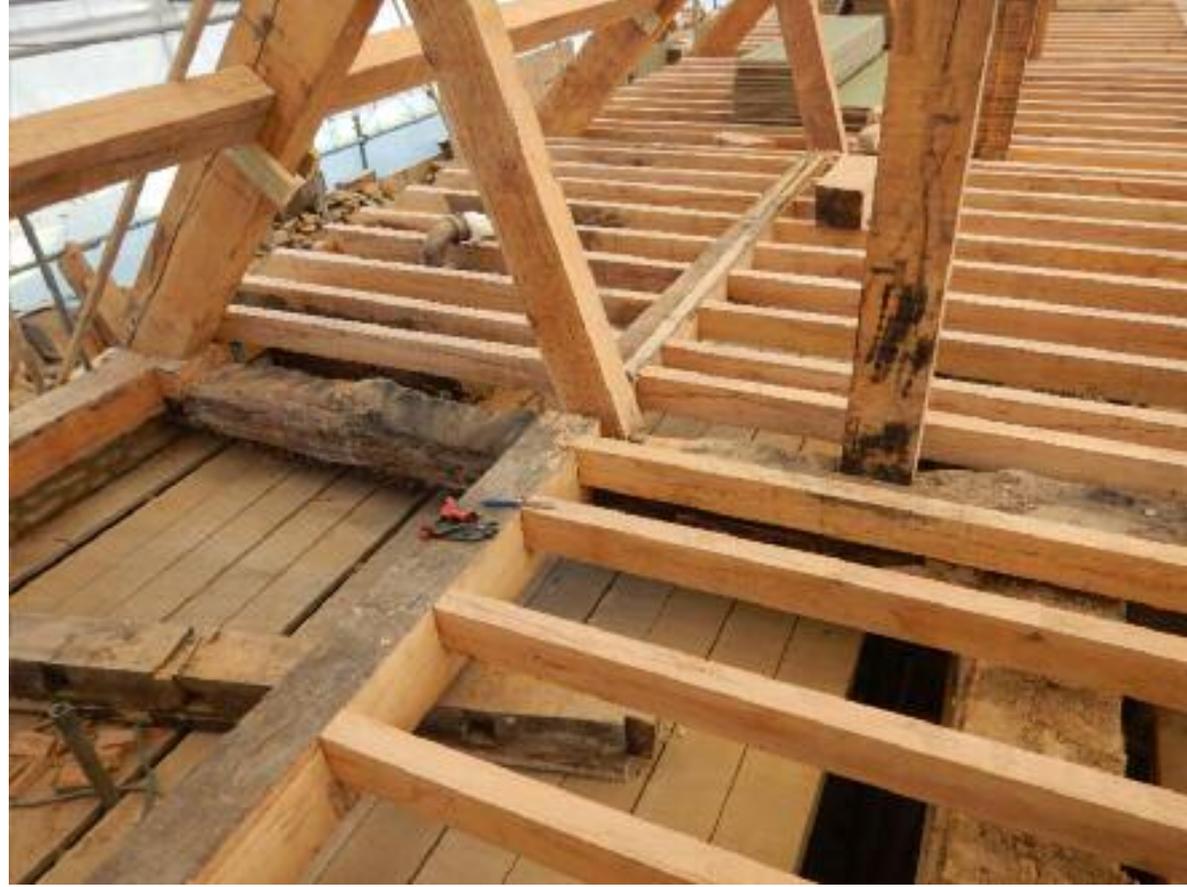
Top: Old and new roof timbers; **Left:** The interior of the building after the work; **Above:** During at beginning of work Castle Ashby protecting and assessing the site

Three of the large oak truss chords spanning the width of the building were only partly damaged and could be retained and repaired in situ. The oak trusses over the garage had previously been supported by a steel beam and cast iron column. This detail was recreated and provided the opportunity to splice the two new
